**Flood Control Project Maintenance
Levee Inspections****LMA District Cover Sheet****Spring 2014 Levee Inspection Results****American River Flood Control District**

Spring 2014 Levee Inspection Results

American River Flood Control District

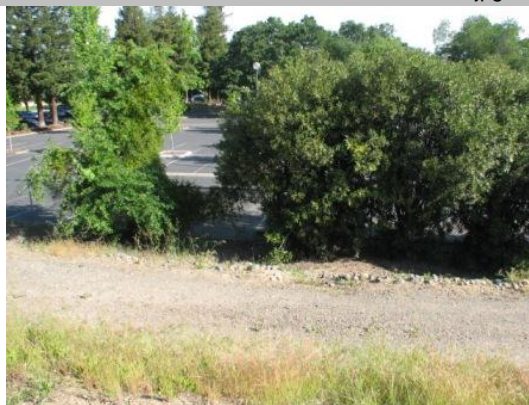
Photo 1 of 1 : mkhashch_s_20140428_00358.jpg

LM Start	3.58	Rating **	M	Issue No.	6
LM End	3.58	Issue Type +	En	Location *	LS
Category	Earthen Levee			GPS Latitude/Longitude	
				Start	End
Item	Vegetation			38.569556 °	38.569556 °
				-121.375302 °	-121.375302 °
DWR ID	DWR_NA0001_10_s_2012_6				
Action/Comments					
Landscaping

Trees at fence line obstruct access and visibility.

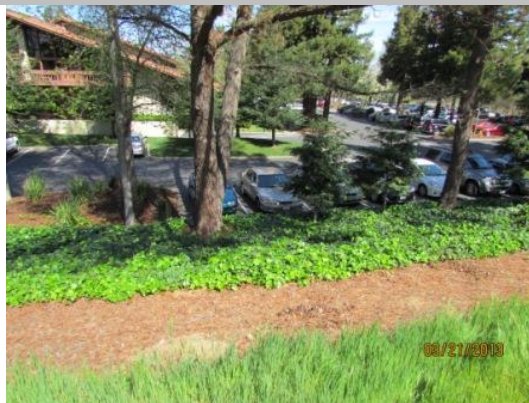
Photo 1 of 1 : mkhashch_s_20140428_00356.jpg

LM Start	3.64	Rating **	M	Issue No.	1
LM End	3.64	Issue Type +	En	Location *	LS
Category	Earthen Levee			GPS Latitude/Longitude	
				Start	End
Item	Vegetation			38.569360 °	38.569360 °
				-121.376388 °	-121.376388 °
DWR ID	DWR_NA0001_10_s_2013_1				
Action/Comments					
Landscaping

View of the landscaping at the levee toe.

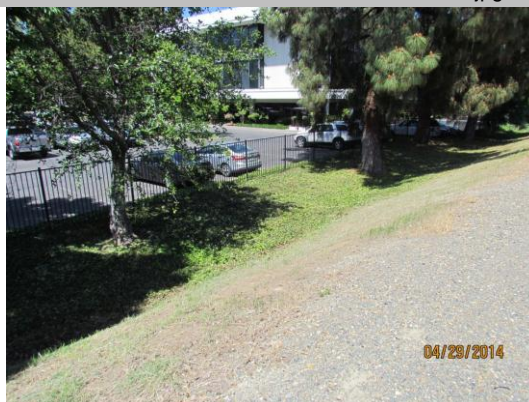
Photo 1 of 1 : mkhashch_s_20140508_00961.jpg

LM Start	3.88	Rating **	M	Issue No.	4
LM End	3.97	Issue Type +	En	Location *	LS
Category	Earthen Levee			GPS Latitude/Longitude	
				Start	End
Item	Vegetation			38.568492 °	38.568076 °
				-121.380477 °	-121.382001 °
DWR ID	DWR_NA0001_10_s_2012_4				
Action/Comments					
Landscaping					
Inspector Comments: Ivy and trees.

View of the landscaping at the landside levee toe and slope.

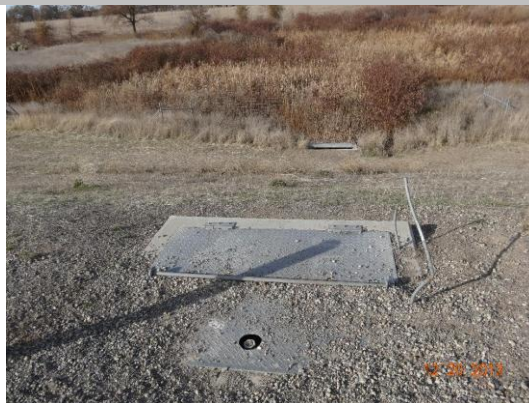
Photo 1 of 1 : UCIP_6405.jpg

LM Start	0.08	Rating **	M	Issue No.	1
LM End	0.08	Issue Type +	En	Location *	LS
Category	Supplemental			GPS Latitude/Longitude	
				Start	End
Item	DWR UCIP Field Study			38.662976 °	38.662976 °
				-121.456464 °	-121.456464 °
DWR ID	DWR_NA0001_11_s_2014_1				
Action/Comments					
Inspector Comments: FS_ID:31310					
EP_NO: N/A					
Repair Type:					
Crossing Status:					
UCIP Comments: no permit found--owner? (unauthorized?)					
FIELD_STRUCT_DESC: 24-inch pipe through the levee at unknown depth. Concrete box located on waterward shoulder. Concrete wall located on waterward and landward side. Siphon breaker inside concrete service box located on waterward shoulder. No permit found.					
FS Date: 12/20/2013

View of waterward side.

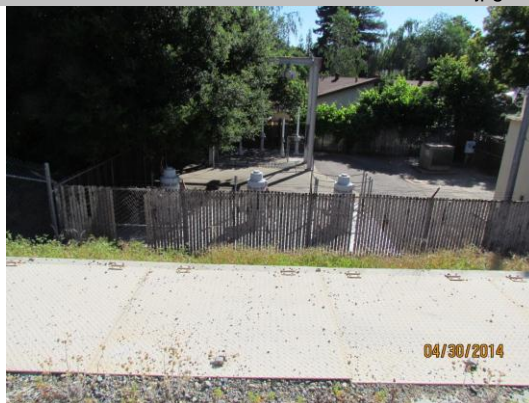
Photo 1 of 1 : mkhashch_s_20140508_00965.jpg

LM Start	0.05	Rating **	A/W	Issue No.	4
LM End	0.05	Issue Type +	En	Location *	LS
Category	Earthen Levee			GPS Latitude/Longitude	
				Start	End
Item	Encroachments			38.570691 °	38.570691 °
				-121.353550 °	-121.353550 °
DWR ID	DWR_NA0001_12_s_2014_4				
Action/Comments					
Pipe					
Inspector Comments: 3 pipes across levee.

View of the pumping facility at the landside levee toe.

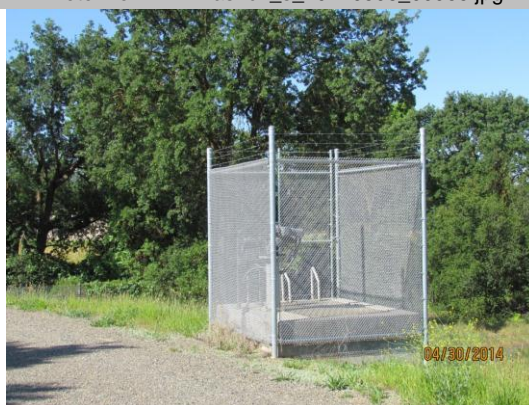
Photo 1 of 1 : mkhashch_s_20140508_00966.jpg

LM Start	0.06	Rating **	A/W	Issue No.	3
LM End	0.06	Issue Type +	En	Location *	CR
Category	Earthen Levee			GPS Latitude/Longitude	
				Start	End
Item	Encroachments			38.570879 °	38.570879 °
				-121.353566 °	-121.353566 °
DWR ID	DWR_NA0001_12_s_2014_3				
Action/Comments					
Pipe

View of the access hole at the waterside levee hinge.

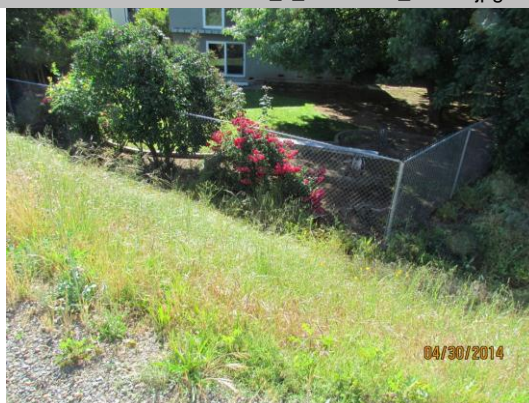
Photo 1 of 1 : mkhashch_s_20140508_00967.jpg

LM Start	0.07	Rating **	M	Issue No.	2
LM End	0.07	Issue Type +	En	Location *	LS
Category	Earthen Levee			GPS Latitude/Longitude	
				Start	End
Item	Vegetation			38.571036 °	38.571036 °
				-121.353441 °	-121.353441 °
DWR ID	DWR_NA0001_12_s_2014_2				
Action/Comments					
Landscaping

View of the landscaping at the landside levee toe.

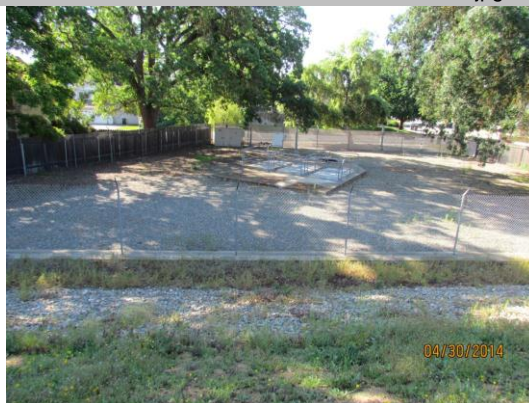
Photo 1 of 1 : mkhashch_s_20140508_00968.jpg

LM Start	0.71	Rating **	A/W	Issue No.	1
LM End	0.71	Issue Type +	En	Location *	LS
Category	Earthen Levee			GPS Latitude/Longitude	
				Start	End
Item	Encroachments			38.576533 °	38.576533 °
				-121.344134 °	-121.344134 °
DWR ID	DWR_NA0001_12_s_2014_1				
Action/Comments					
Pipe					
Inspector Comments: Wastewater pipes through the levee.

View of the wastewater pipe crossing the levee.
